## Timber chutes

### Timber chutes- older remains

### Agnelåns timber chutes

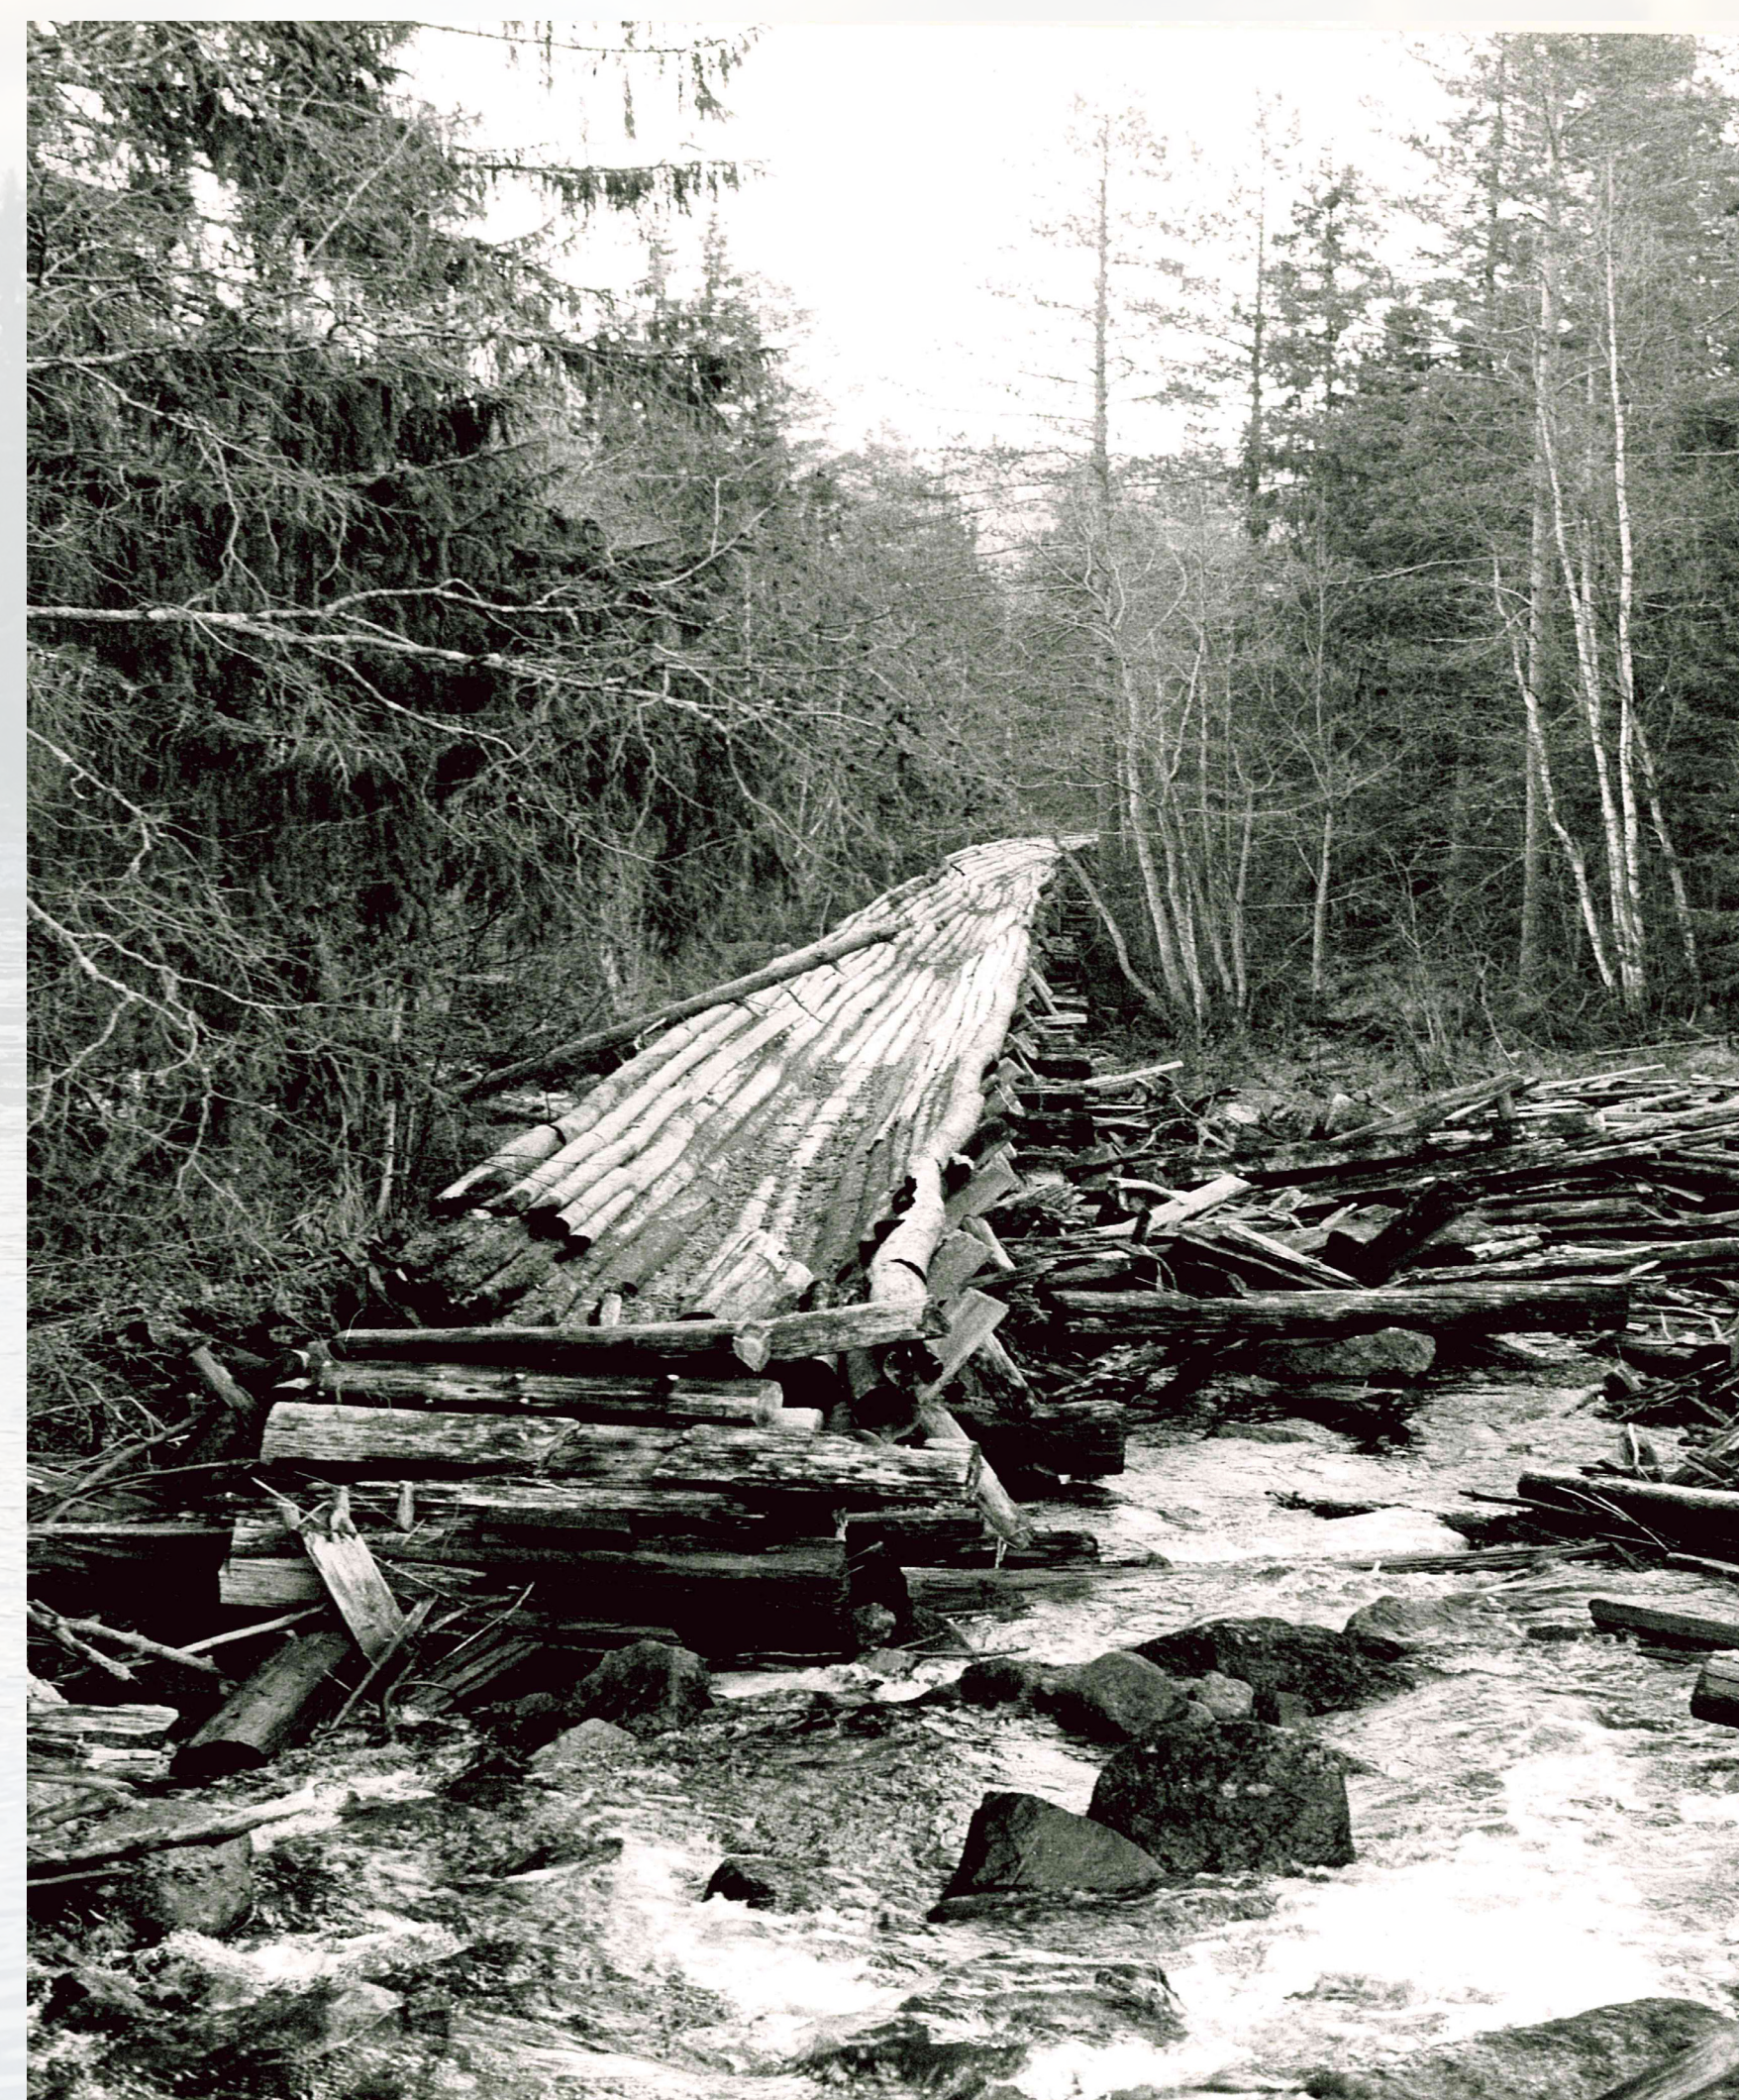
Chute in the Agnelån river approximately 400 meters downstream from Gråssjön. The photo is taken in the early 1970's.

Timber chutes were a way to efficiently navigate logs past sections of watercourses where it was challenging to float them. Usually, you find timber chutes at waterfalls, where the watercourse flows slowly and meanders, especially where there are large boulders, as is the case here.

Constructing timber chutes was time-consuming and expensive; moreover, they required significant maintenance. With the advent of new technologies such as dynamite and excavation machinery, it simply became cheaper to blast apart rocks and stones than to maintain the old timber chutes. For this reason, timber chutes are often considered an older part of the timber floating route.

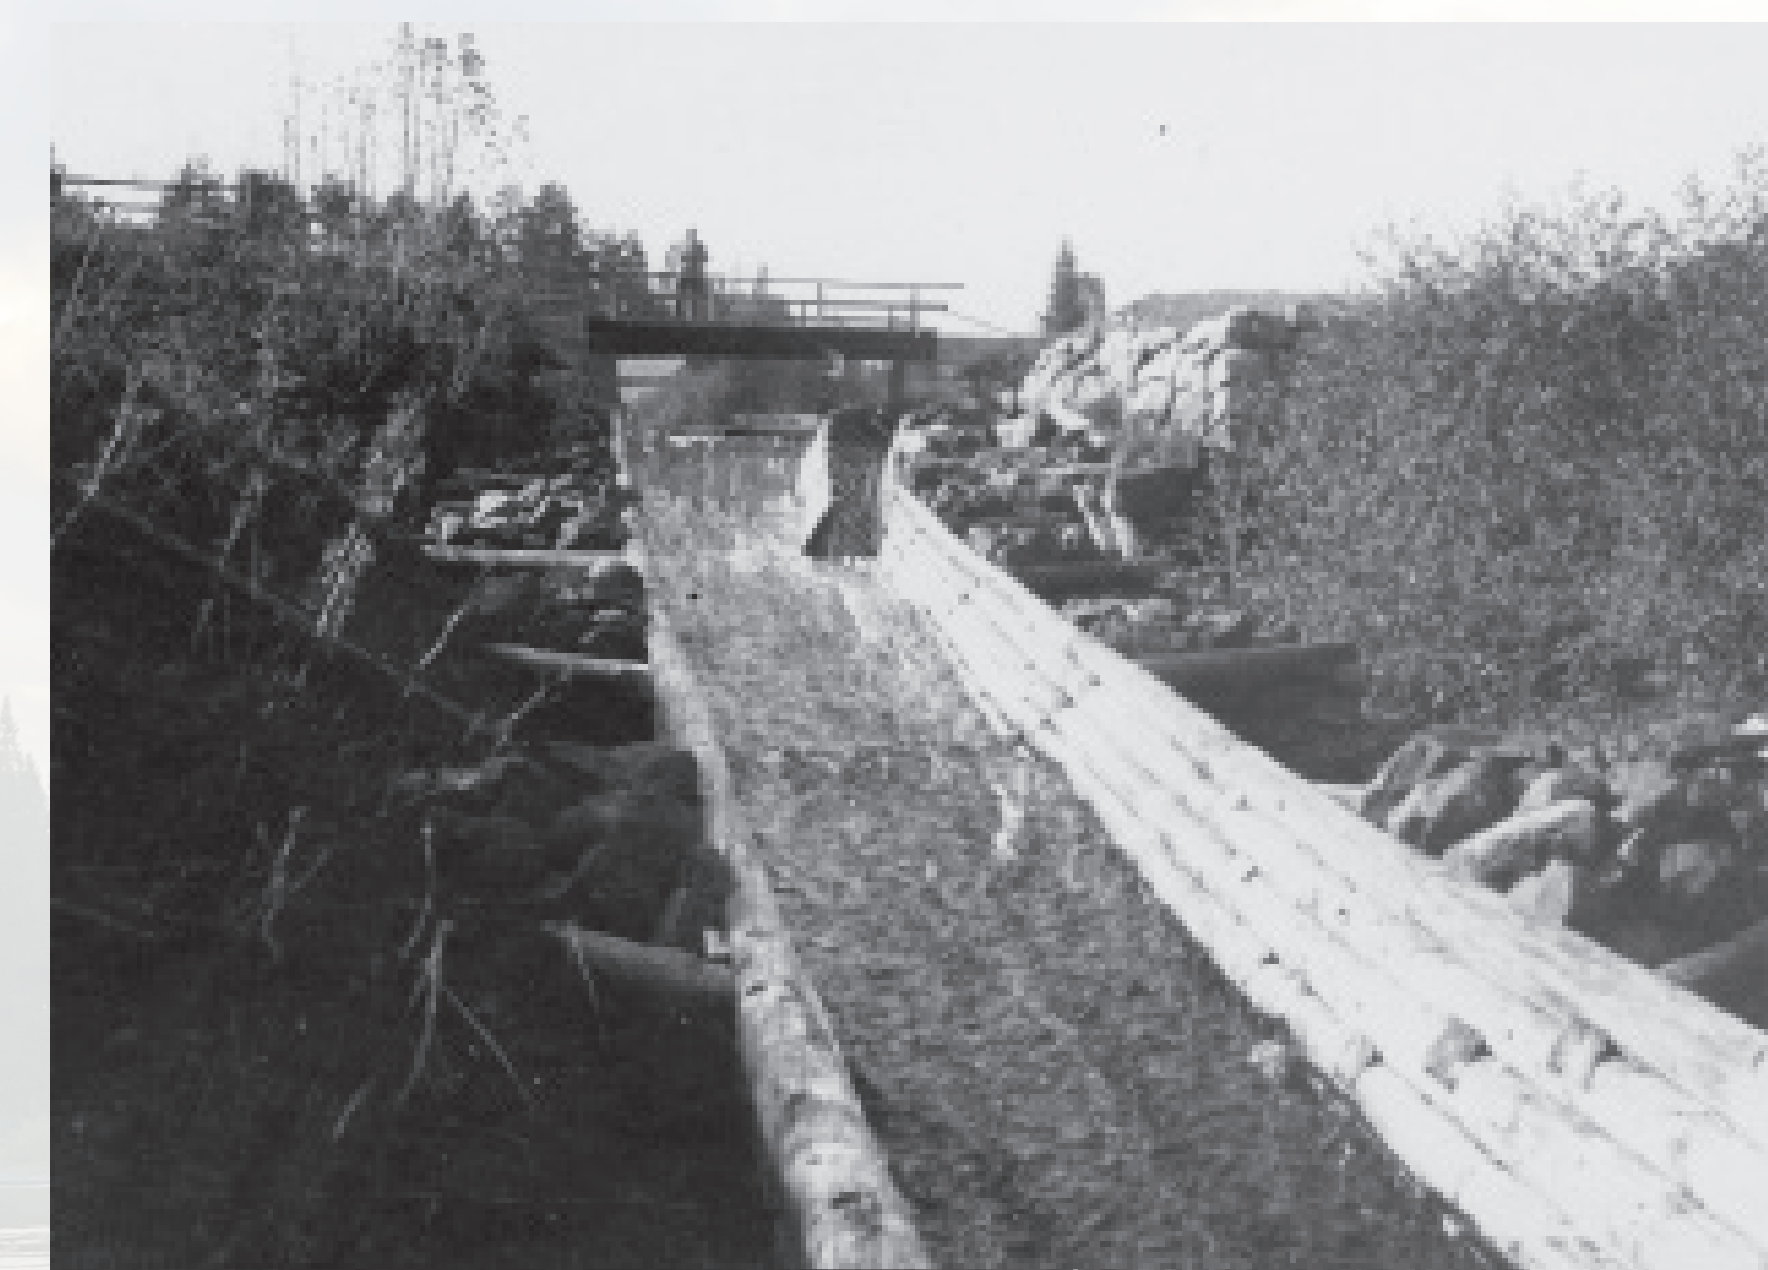
When you lift your gaze from this sign, you can see the traces of one of Agnelån's timber chutes. A hundred years ago, these remnants were an imposingly timbered chute; today, the traces of it are almost entirely gone. Often, the remnants of the chutes can be seen in the form of corridors of "stave spruce," that is, small spruces growing on top of the remnants of the chute. Here, we have cleared a corridor around the old chute so that you can more easily see where the chute was located.
